TECHNICAL NOTE

No. 1246

WIND-TUNNEL INVESTIGATION OF ICING OF AN ENGINE
COOLING-FAN INSTALLATION

By James P. Lewis

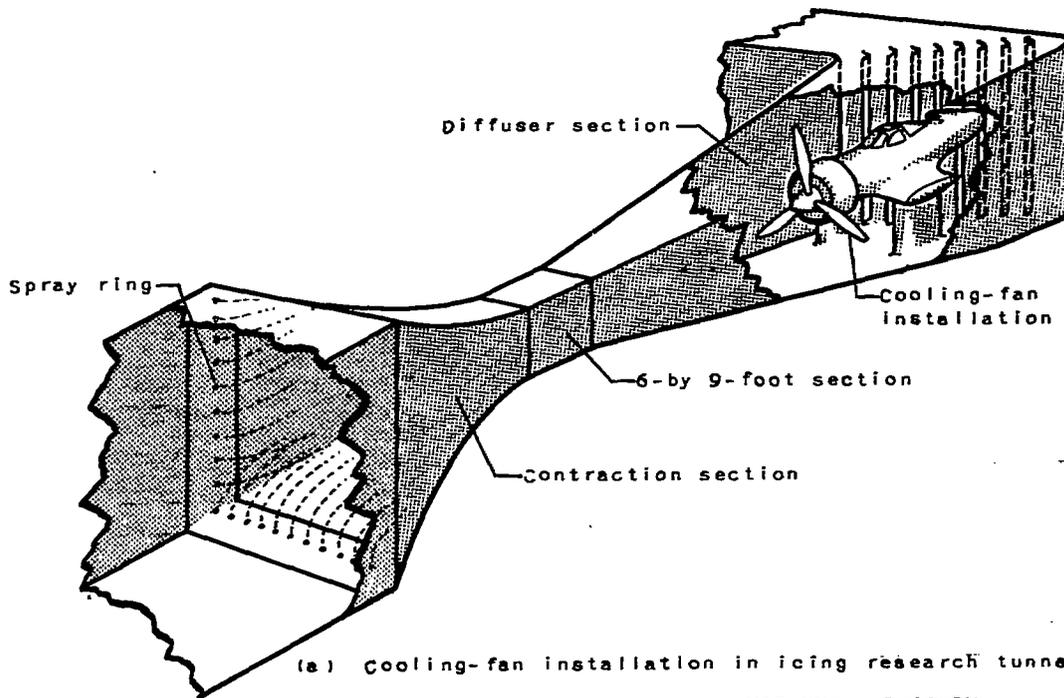
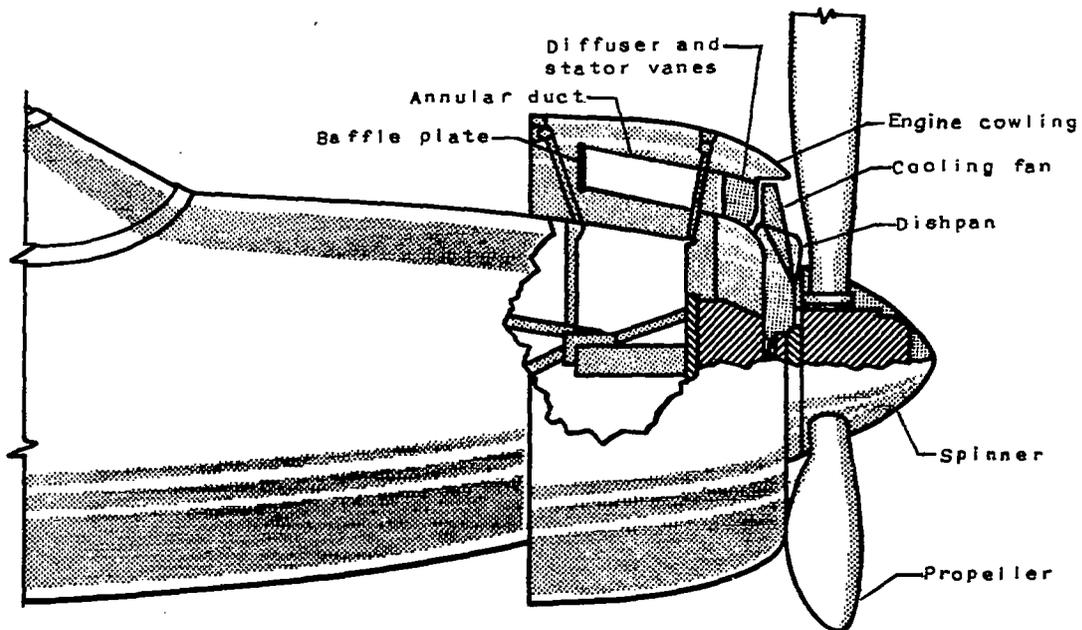
Figure 1. - Engine cooling-fan installation.

The investigation was conducted in the diffuser section of the icing research tunnel. The cooling-fan assembly was mounted on the modified nose section of an airplane fuselage installed in the tunnel. The installation consisted of a typical propeller-speed engine cooling fan, a stator-vane and diffuser assembly, a baffle plate located in a constant-area annular duct downstream of the fan to simulate the pressure drop across the engine, a standard radial-engine cowling, a three-blade propeller and spinner, and necessary instrumentation. (See fig. 1.)

Cooling fan. - The cooling-fan assembly was designed to be mounted at the front face of a radial engine and enclosed by the engine cowling with the fan rotor attached to the rear of the propeller hub and the stator-vane assembly attached to the reduction-gear housing. The front fairing of the fan disk was of the "dishpan" type with a large forward bulge at the outer diameter of the dishpan. The fan had 72 cambered sheet-metal blades with a tip diameter of 45 inches and a tip clearance of three-sixteenths inch. As part of the cooling-fan assembly, 49 cambered sheet-metal stator vanes were located behind the fan to remove the rotational component of the flow. A clearance of seven-eighths inch existed between the fan blades and stator vanes. (See fig. 1.)

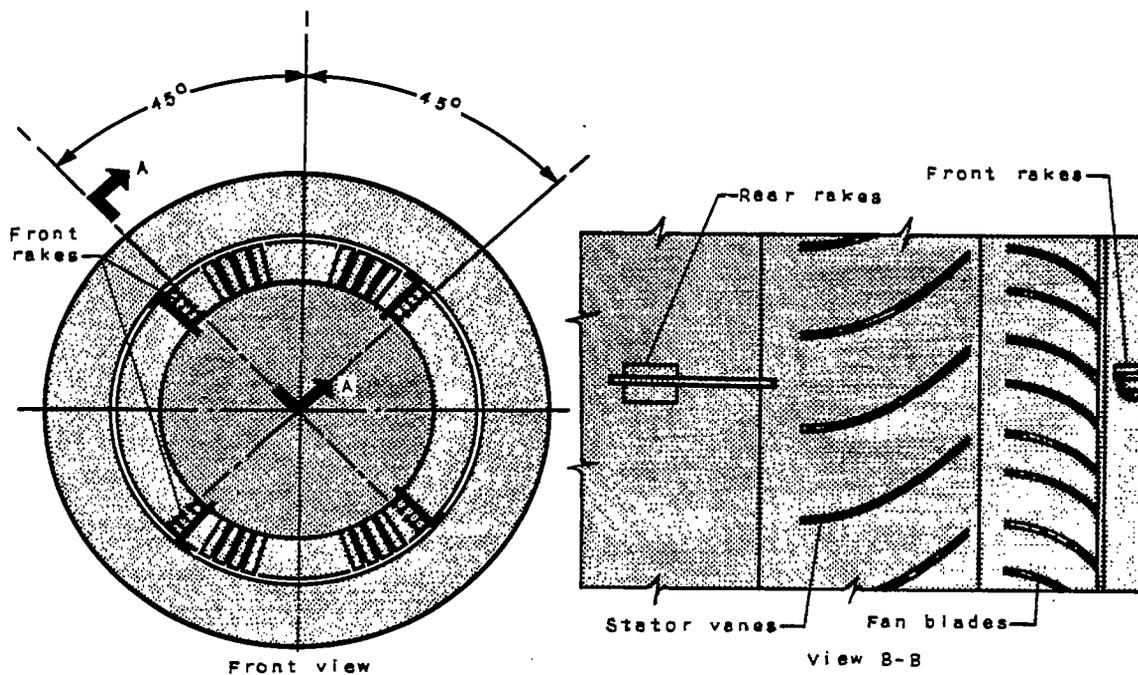
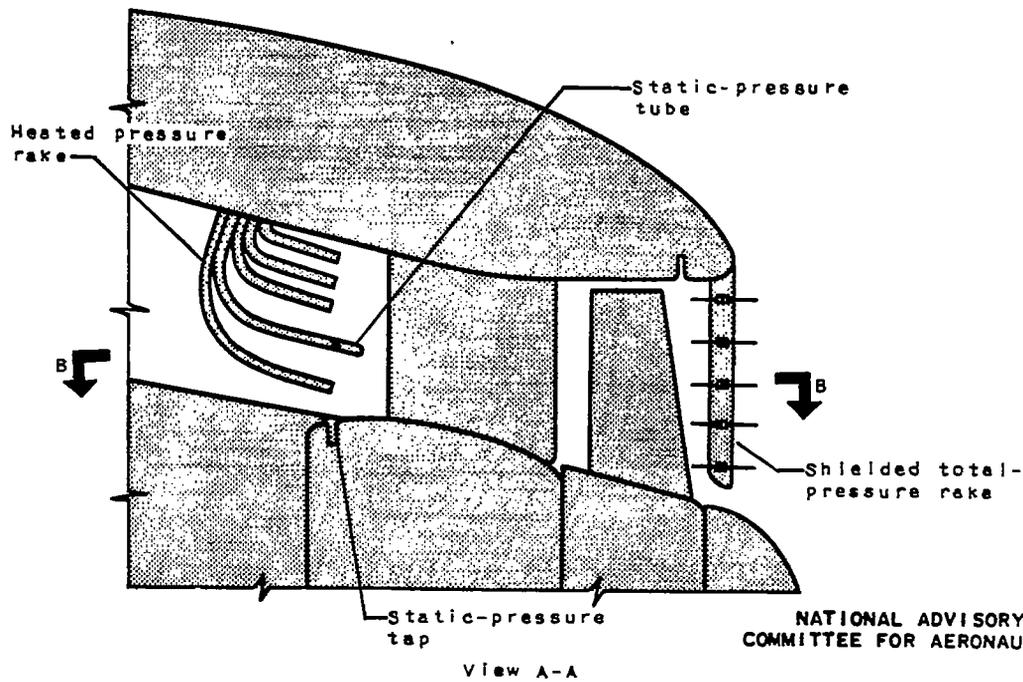
Figure 2. - Location of pressure-tube rakes in cooling-fan installation.

Instrumentation. - Total pressure in front of the fan and total and static pressure behind the stator vanes were measured by pressure-tube rakes (fig. 2). Four equally spaced rakes of shielded total-pressure tubes were located at the lip of the engine cowling between the fan and propeller. These rakes were unheated because of the extreme difficulty in heating small shielded total-pressure tubes and hence were used only on nonicing pressure-distribution studies. Electrically heated rakes consisting of four total-pressure tubes and one static-pressure tube were installed behind the stator vanes at four equally spaced positions corresponding to the positions of the front rakes. In addition, static pressures were measured on the inner wall of the diffuser in the plane of the rear rakes. All the pressures were indicated on a multiple-tube manometer and were photographically recorded.

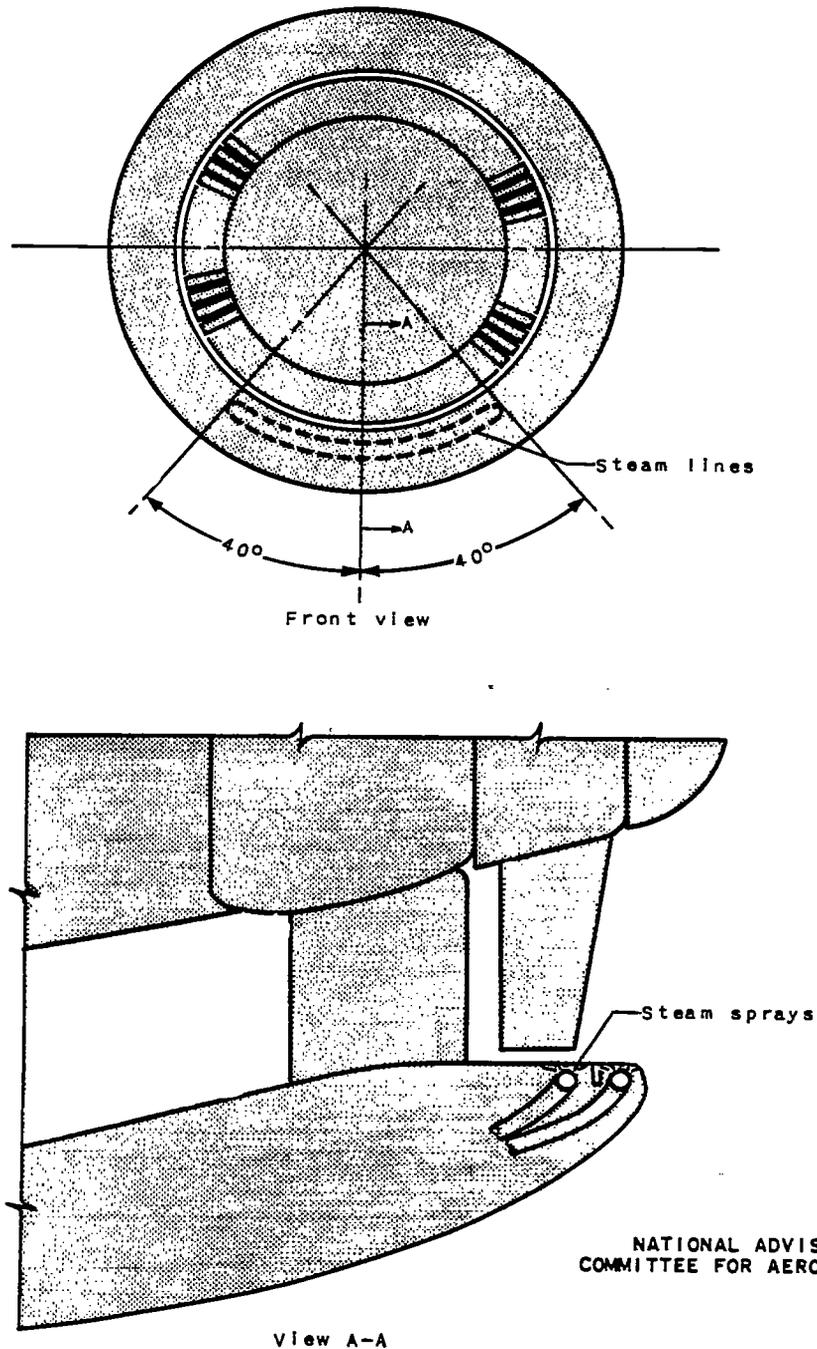
Figure 3. - Location of steam lines in cooling-fan installation.

Steam-heat installation. - In order to investigate the elimination of ice on the engine-cowling lip and the consequent scraping of the fan-blade tips, one steam line with jets 0.10-inch in diameter and spaced 1/2 inch apart was placed inside the cowling lip and another was located outside the inlet duct 2 inches behind the first line (fig. 3). These lines were of 3/8-inch copper tubing and extended approximately 40° on each side of the center line in the lower half of the cowling. Steam heating was confined to the lower quarter of the cowling because of time limitations and also to provide an unheated area for comparison.

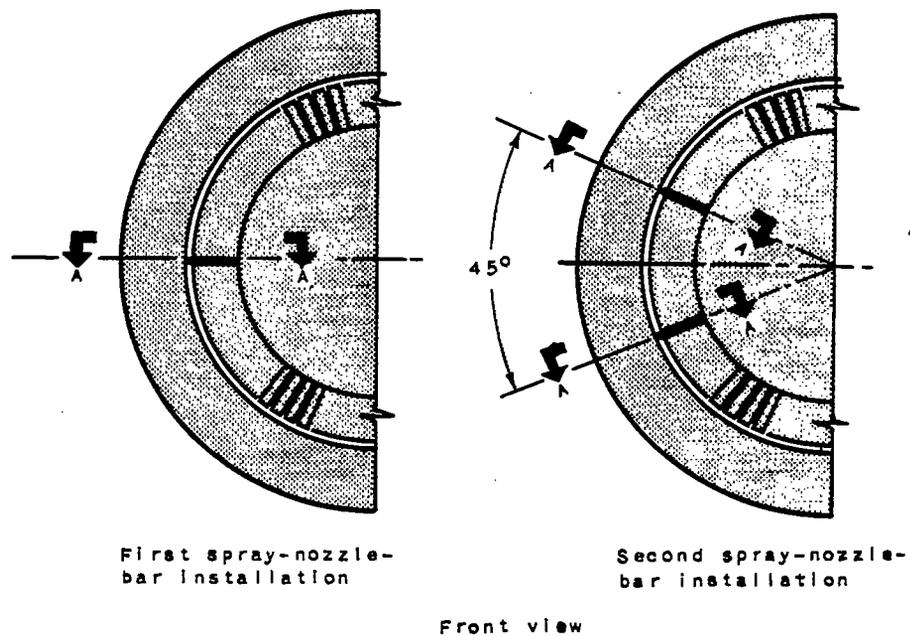
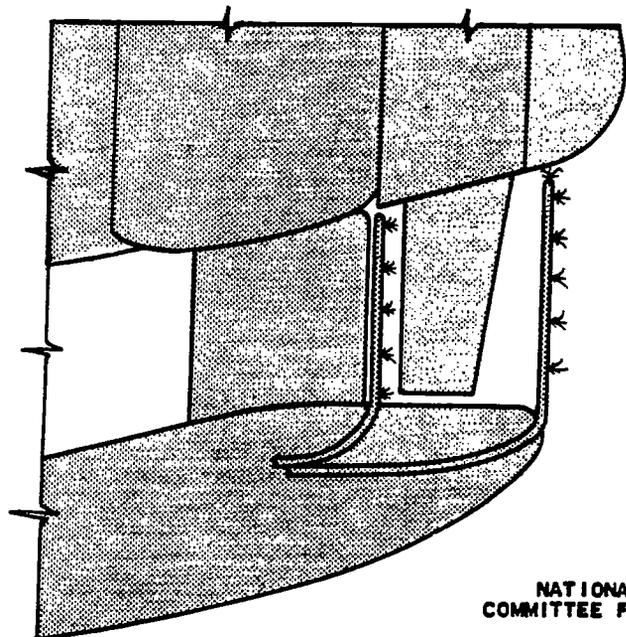
Figure 4. - Location of alcohol spray nozzle bars in cooling-fan installation.

Alcohol de-icing installation. - In the investigation of the use of isopropyl alcohol for de-icing, spray nozzle bars were mounted radially in front of the fan blades and also between the fan blades and the stator vanes (fig. 4). The spray nozzle bars, consisting of tubes having six small jets each 0.070 inch in diameter, were mounted to spray the alcohol forward in an attempt to obtain a good spray dispersion and at the same time to keep the spray tubes de-iced. For the first installation a single nozzle bar was mounted horizontally in front of the fan blades and one in a corresponding position was mounted at the leading edge of the stator vanes. For the second installation two spray nozzle bars located approximately 45° apart were similarly mounted in front of the fan blades and two spray nozzle bars were also mounted at the leading edge of the stator vanes. This second configuration was used to obtain a greater coverage of alcohol on the stator vanes and to accommodate greater flows. A variable-control alcohol pump provided flow rates up to 2.3 pounds per minute.

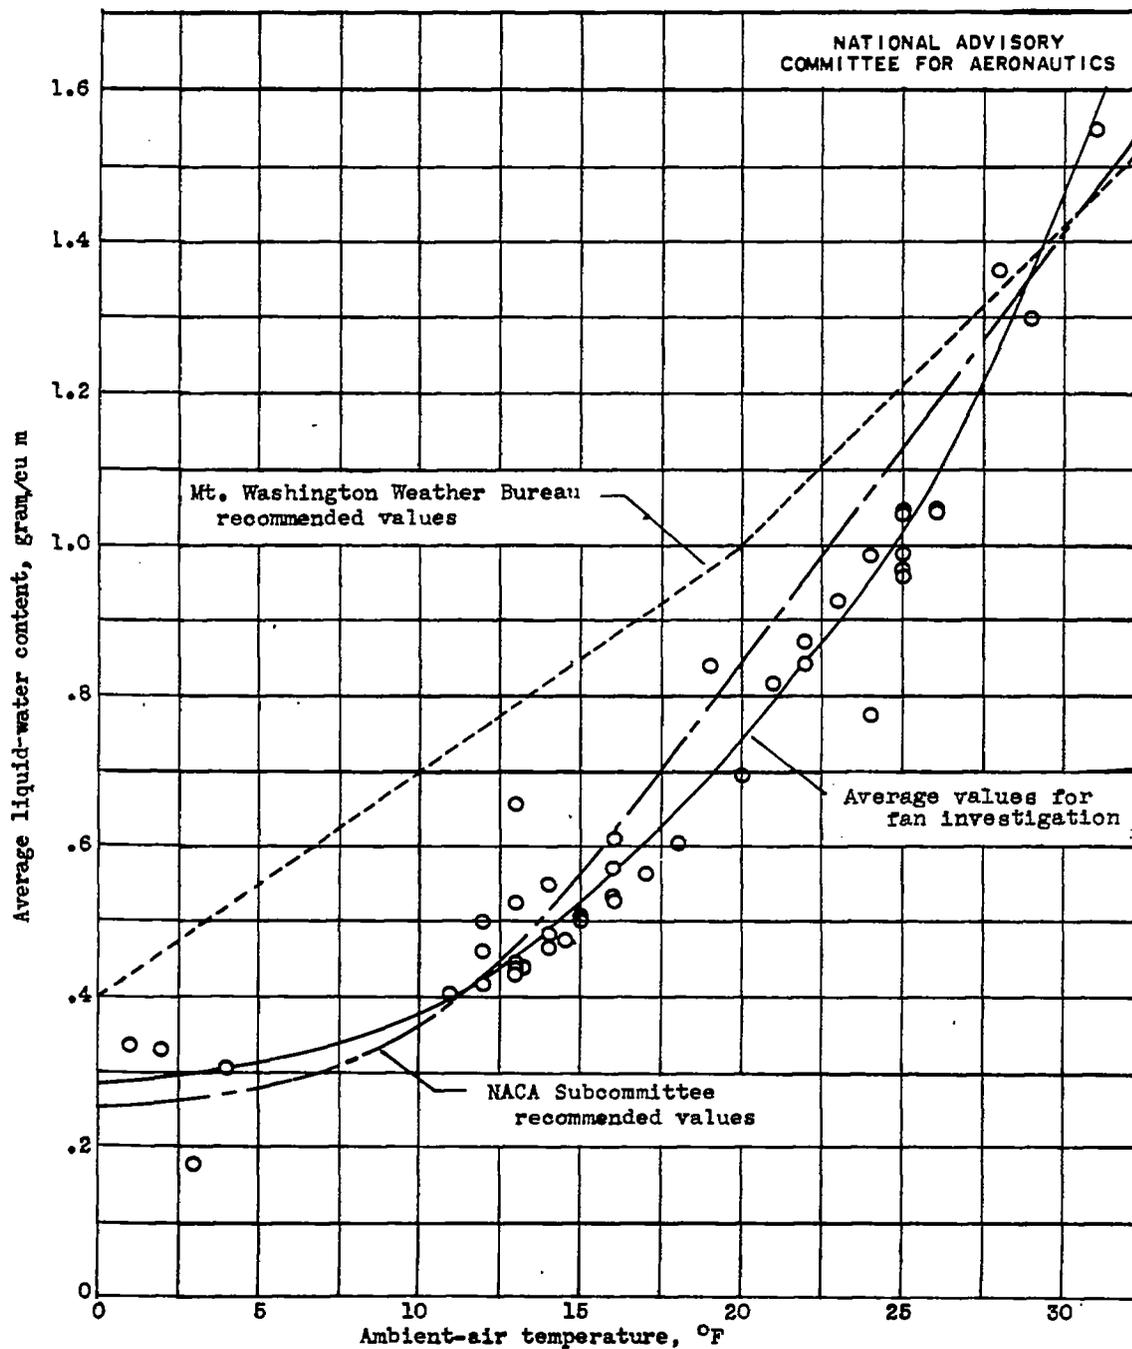
Figure 6. - Comparison of liquid-water content in icing research tunnel with recommended values.

Calibration of tunnel-icing conditions. - The icing conditions were defined by the ambient-air temperature and liquid-water content of the air. Figure 6 presents the variation of liquid-water content

with air temperature at the face of the cooling fan as determined by a survey conducted in the diffuser section of the icing research tunnel and a comparison of these conditions with the values recommended by the NACA Subcommittee on De-Icing Problems and by the Mt. Washington Weather Bureau meeting on June 19, 1945. The subcommittee values are one-half of the recommended maximum values and are for average or typical icing. Vertical cylinders rotating about their axes were installed in the diffuser section and, from measurements of the local velocity and the ice accumulation per unit time on these cylinders, the average liquid-water content in grams per cubic meter for each condition of tunnel air velocity, ambient-air temperature, and spray-water input pressure was computed by the method of Langmuir of the General Electric Company. Droplet size was also measured but no consistent correlation with air temperature was obtained. An average droplet size of 55 microns was obtained in the icing research tunnel for the range of air temperature of 0° to 32° F as compared with the recommended averages of 10 and 30 microns, respectively, at these temperatures. This variation in droplet size was not considered important, however, because the collection efficiency of small objects such as the thin fan blades and stator vanes is known to be very close to 100 percent. Although the liquid-water concentrations are slightly less than the recommended values for most of the temperature range, the experimental values are nevertheless representative of moderate-to-light icing conditions encountered in the United States. This survey was made approximately 3 months before the cooling-fan investigation. Although time limitations prevented any extensive checks of the liquid-water content and distribution, visual observations of the spray cloud and icing of the installation and tunnel, together with readings of spray-water input pressures, indicated that the icing conditions were fairly constant and in fairly close agreement with the indicated values for the cooling-fan investigation. A velocity survey made after this investigation indicated, however, that the icing of the contraction section of the tunnel resulted in an increase in the thickness of the tunnel boundary layer with a corresponding increase in the velocity at the center of the tunnel. In addition to the change in velocity distribution, this increase in boundary layer also caused some changes in liquid-water content and distribution.

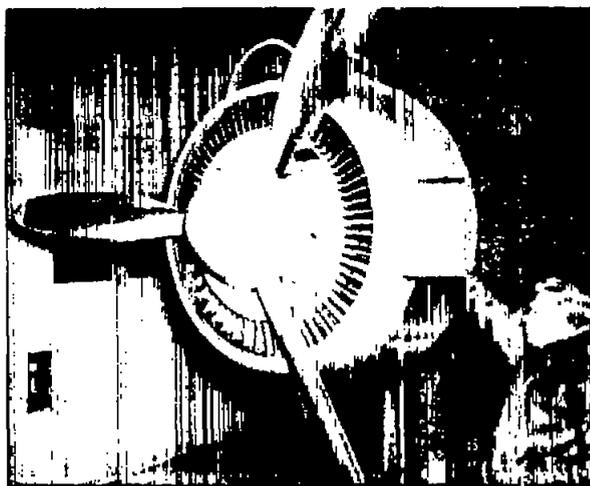
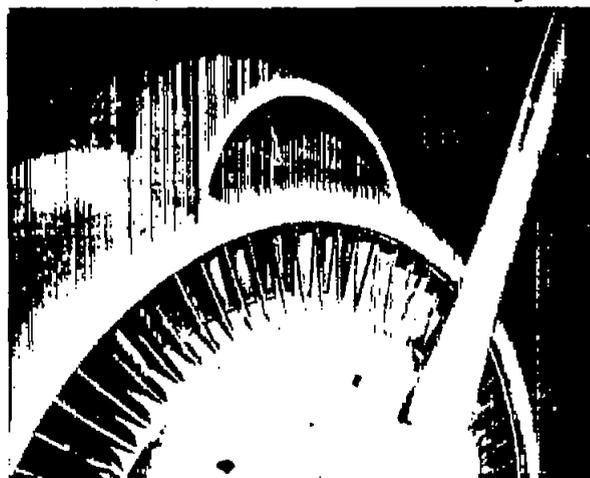
(a) General view of icing.

(b) Close-up of fan blades.

(c) Views of spinner and fan.

Figure 7. - Ice formations on cooling-fan installation after 5-minute run at air temperature of 2°F , liquid-water content of 0.3 gram per cubic meter, and fan speed of 872 rpm.

The only condition at which the air-flow coefficient ratio did not markedly decrease was at an air temperature of 2° F, liquid-water content of 0.3 gram per cubic meter, and fan speed of 872 rpm (fig. 13). Photographs of icing at these conditions (fig. 7) show only a negligible ice build-up on both the fan blades and stator vanes. At 16° F, 0.5 gram per cubic meter, and 897 rpm, the air-flow coefficient ratio decreased, approaching the minimum required value in 5 minutes; whereas at 14° F, 0.5 gram per cubic meter, and 1060 rpm the flow-coefficient ratio fell to the minimum required value in $3\frac{3}{4}$ minutes, continued to decrease, and reached a fairly stable value after 6 minutes. Photographs of typical icing at these two conditions (figs. 8 and 9) show relatively light icing of the stator vanes at both speeds with most of the ice on the leading edge and concave face of the fan blades and extremely large formations at the higher fan speed. At approximately the same fan speeds, as the experiments at 897 and 1060 rpm, and at 23° F, and 0.9 gram per cubic meter, the cooling-air-flow coefficient fell off sharply, reaching the minimum required value in 2 to 3 minutes, and continued to decline with a complete stoppage of the flow occurring in 5 to 6 minutes. Photographs of typical icing at these conditions (figs. 10 and 11) show relatively little ice on the fan blades with the stator vanes completely blocked by very heavy formations.

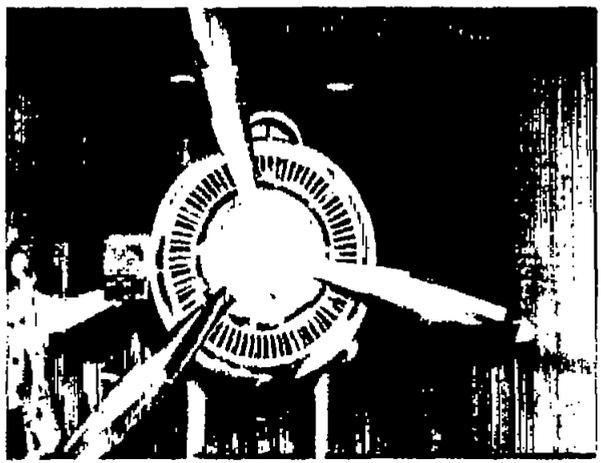
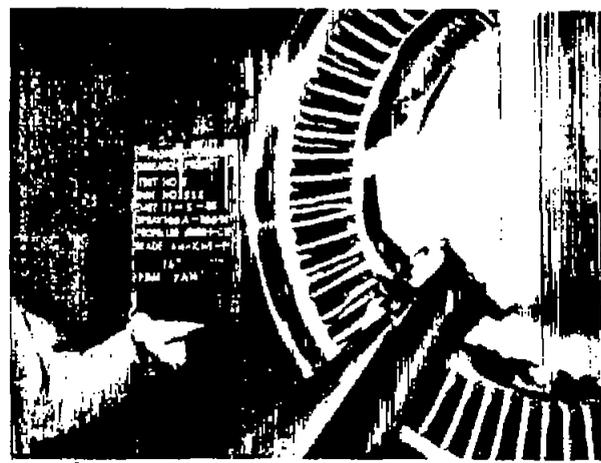
(a) General view of icing.

(b) View of ice formations on fan and spinner.

(c) Close-up of fan blades.

(d) View looking forward showing ice formations on stator vanes.

Figure 8. - Ice formations on cooling-fan installation after 5-minute run at air temperature of 46° F, liquid-water content of 0.5 gram per cubic meter, and fan speed of 897 rpm.

The variation in the pressure-coefficient ratio at the same speed and icing conditions (fig. 14) exhibited similar trends. At 14° and 16° F (figs. 8, 9, and 14), the decrease in pressure coefficient was primarily due to icing of the fan blades.

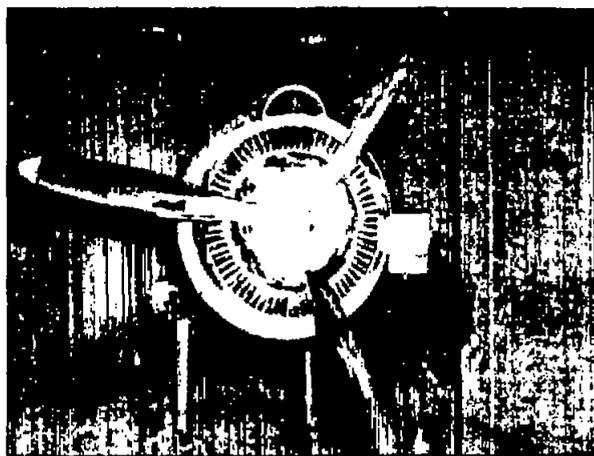
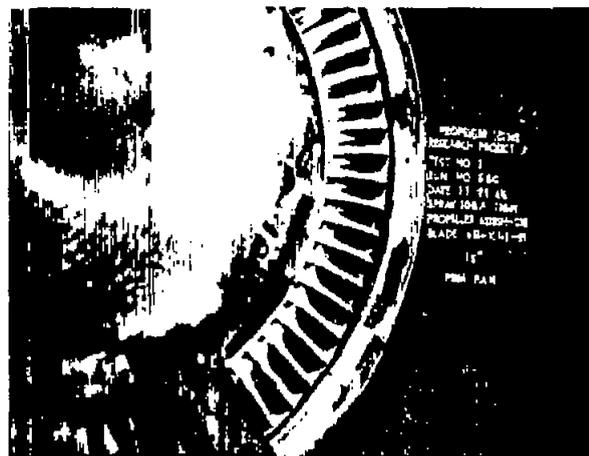
(a) General view of ice formations.

(b) View showing ice formations on fan blades.

Figure 9. - Ice formations on cooling-fan installation after 10-minute run at air temperature of 14° F, liquid-water content of 0.5 gram per cubic meter, and fan speed of 1060 rpm.

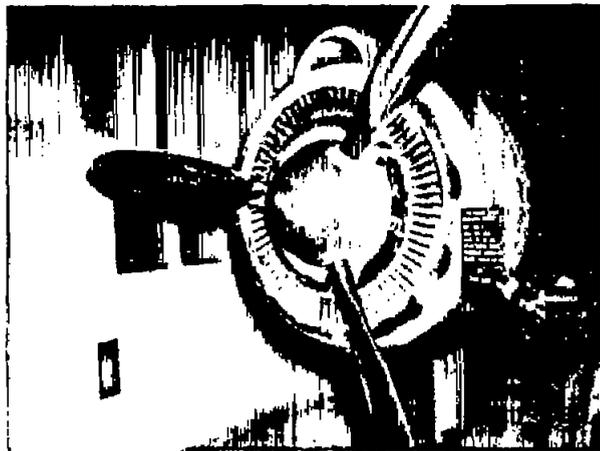
(a) General view of ice formations.

(b) Close-up of ice formations on fan and spinner.

(c) Close-up showing ice formations on fan blades and blocking of stator vanes.

(d) View looking forward showing ice formations blocking stator vanes.

Figure 10. - Ice formations on cooling-fan installation after 5-minute run at air temperature of 23° F, liquid-water content of 0.9 gram per cubic meter, and fan speed of 872 rpm.

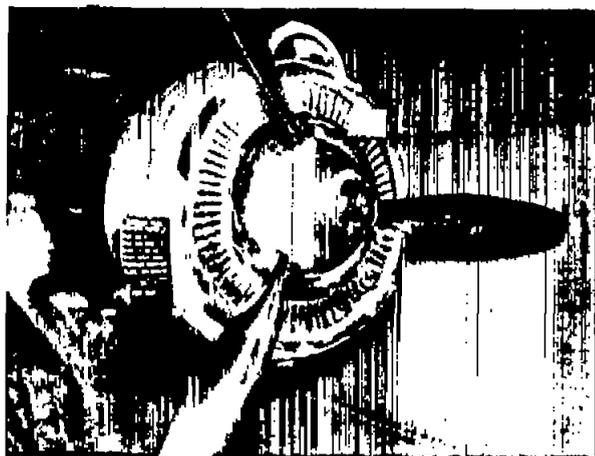
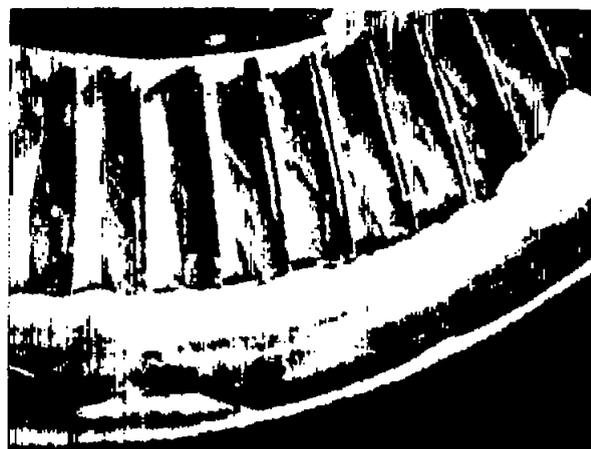
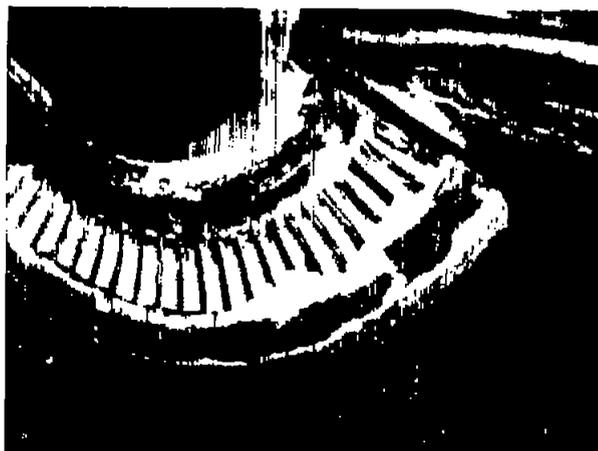
(a) General view of ice formations.

(b) Close-up of ice formations on fan blades.

(c) Close-up showing blocking of stator vanes.

(d) View looking forward showing ice formations on stator vanes.

Figure 11. - Ice formations on cooling-fan installation after 7-minute run at air temperature of 23° F, liquid-water content of 0.9 gram per cubic meter, and fan speed of 1065 rpm.

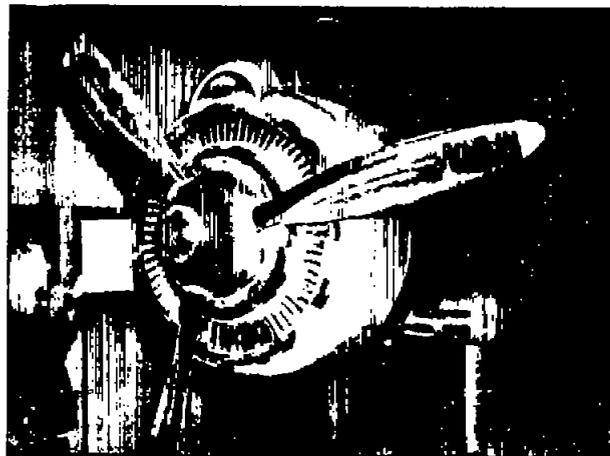
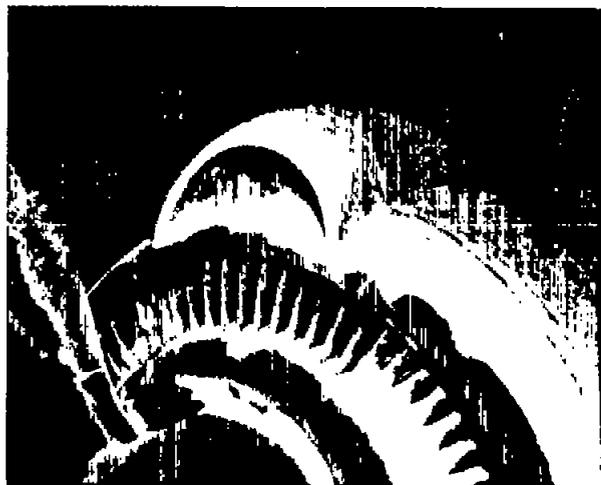
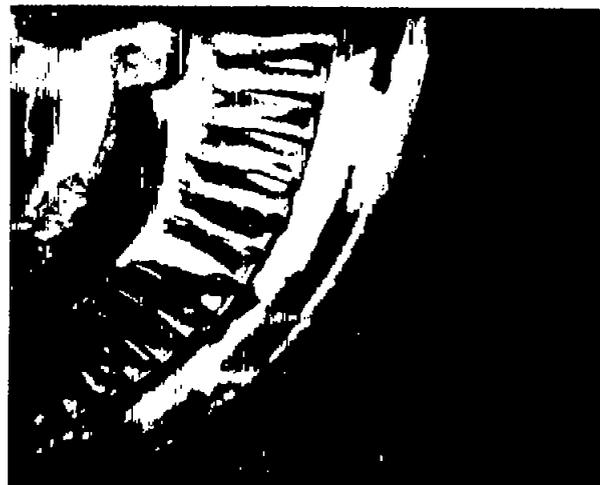
(a) General view of ice formations.

(b) Close-up showing bridging of ice over fan blades.

(c) Close-up showing blades that had thrown off ice.

Figure 12. - Ice formations on cooling-fan installation after 5-minute run at air temperature of 17° F, liquid-water content of 0.7 gram per cubic meter, and fan speed of 872 rpm.

Although no performance data were obtained at 17° F and 0.7 gram per cubic meter, visual observations revealed serious icing at this condition. As shown by the photographs in figure 12, heavy icing of the fan blades was obtained with medium formations

on the thrust face and leading edge of the stator vanes. At one time during this run, stroboscopic observations showed the fan blades to be fully bridged over but much of this ice was later thrown off.

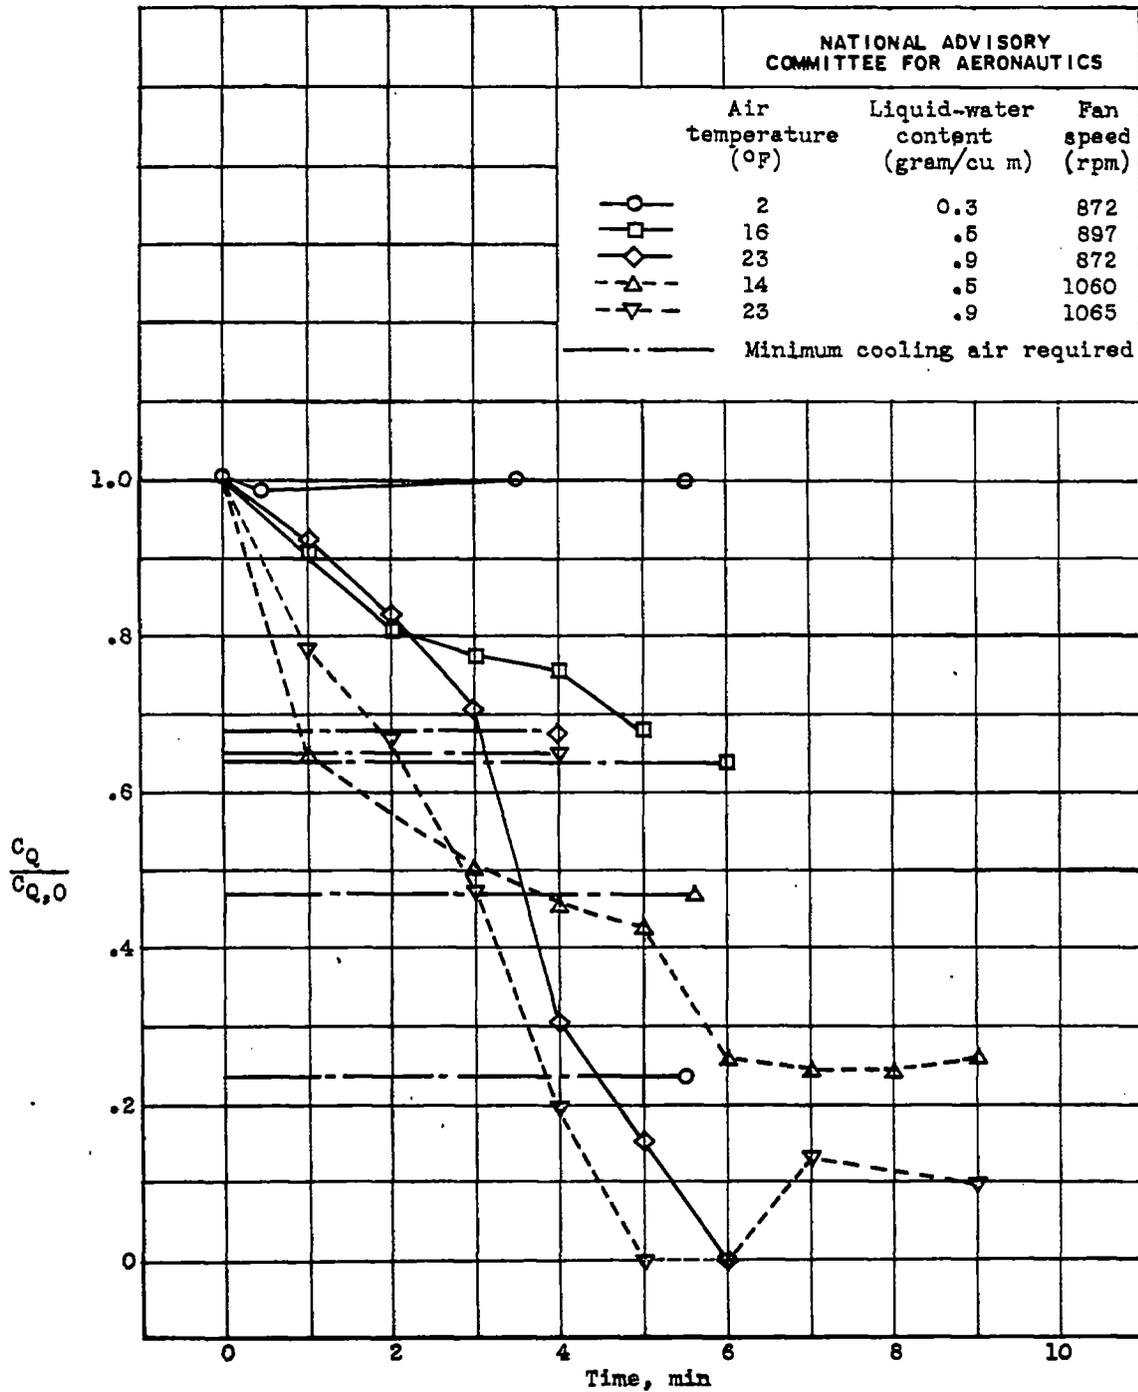
Figure-13. - Reduction in cooling-air-flow coefficient ratio for various icing and fan-speed conditions for investigation of cooling-fan installation.

Icing. - Photographs showing typical icing of the fan assembly at the conditions tested are shown in figures 7 to 12. The effects of icing on fan performance are shown in figures 13 and 14 where the ratios of the air flow and fan pressure of the iced fan to that

of the fan before icing $\frac{C_Q}{C_{Q,0}}$ and $\frac{C_P}{C_{P,0}}$, respectively, are plotted against icing time. Although insufficient data were available to compare the effects of icing at all icing and performance conditions, the results shown in figures 13 and 14 are complete enough to define the effects of icing on fan performance throughout the normal range of icing and performance conditions. The minimum air flow required for adequate engine cooling is indicated in figure 13 as computed from data supplied by the engine manufacturer.

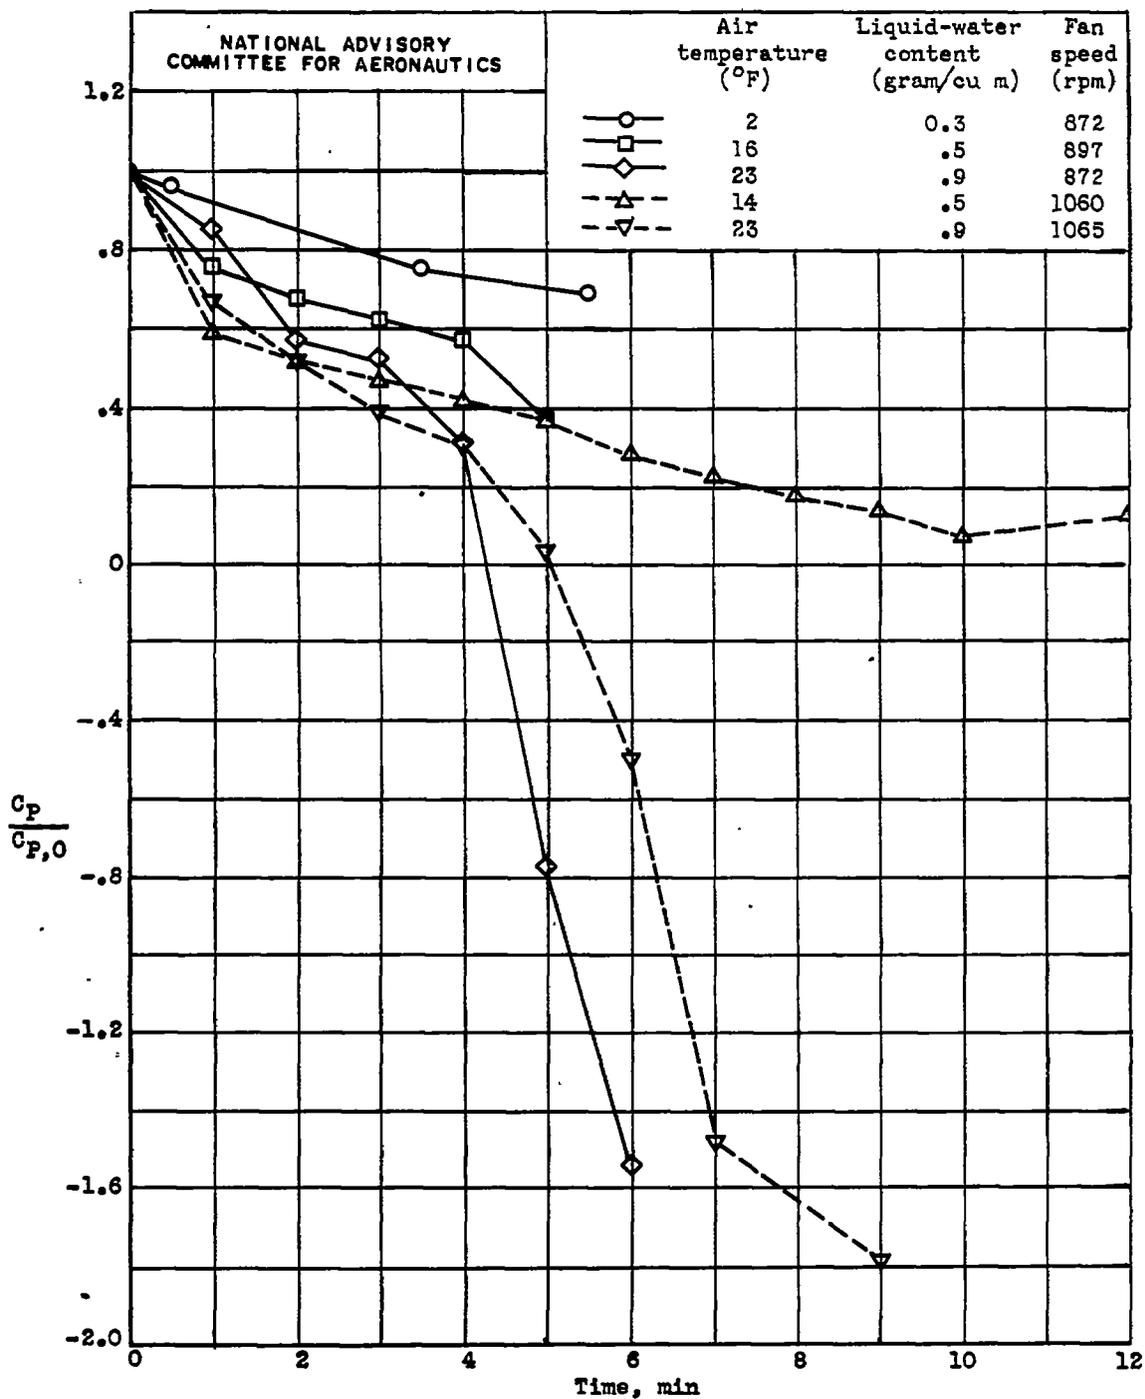
Figure 14. - Reduction in fan-pressure coefficient ratio for various icing and fan-speed conditions for investigation of cooling-fan installation.

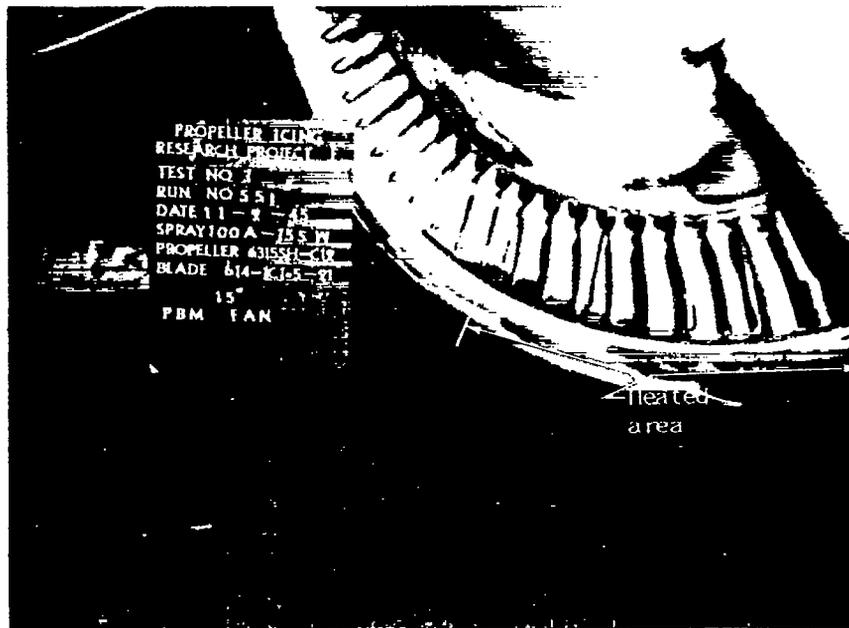
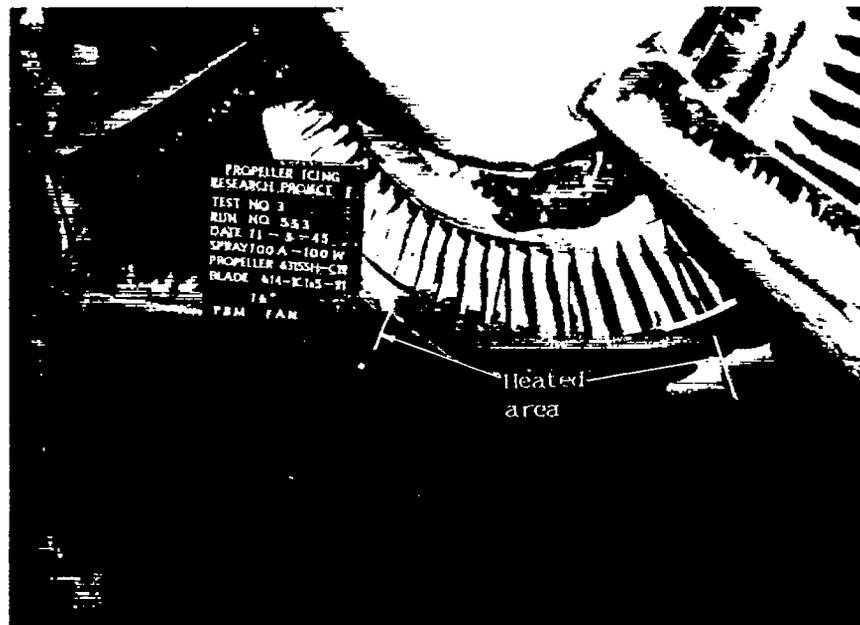
(a) Close-up showing de-icing with single steam line. Air temperature, 13° F; liquid-water content, 0.4 gram per cubic meter; fan speed, 874 rpm.

(b) Close-up showing de-icing with double steam line. Air temperature, 16° F; liquid-water content, 0.5 gram per cubic meter; fan speed, 917 rpm.

Figure 15. - Views showing effect of steam-heat de-icing of cowling and inlet duct in cooling-fan installation after 5 minutes of icing.

Steam-heat de-icing. - The results of a brief qualitative investigation of the use of steam for de-icing the cowling lip and inlet duct are shown in figure 15. Figure 15(a) shows the results of de-icing with a single steam line placed outside the inlet duct at the tip of the fan blades. The heated area started to throw off ice 50 seconds after the steam was turned on and all the ice was removed within 2 minutes with the heated area remaining clear thereafter. In a delayed de-icing run with the same configuration, steam was turned on after 5 minutes of icing and the ice in the heated area was thrown off within 30 seconds. With the double steam line installed (fig. 15(b)), a slightly greater area including the lip of the engine cowling was de-iced in the same time. From these results, it appears that the de-icing of these areas by means of hot gases is entirely feasible.

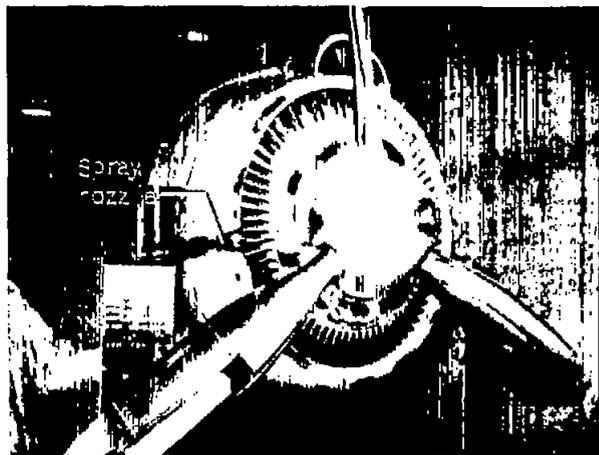
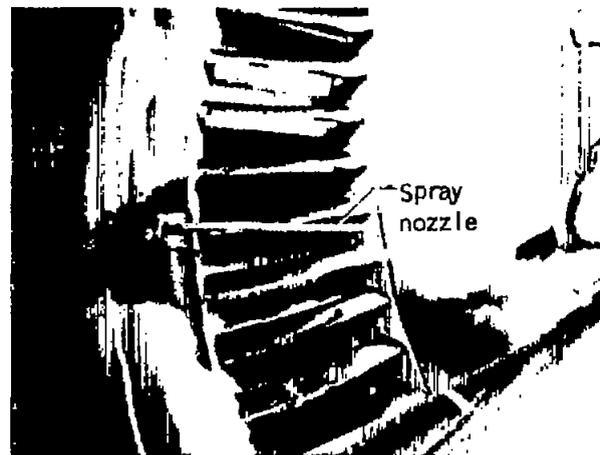
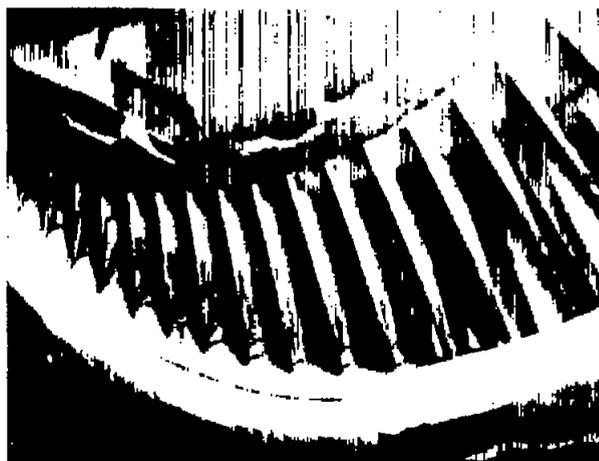
(a) General view of installation.

(b) Close-up of spray nozzle bar.

(c) Close-up of thrust face of fan blades.

(d) View looking forward through stator vanes.

Figure 16. - Views showing effect of alcohol de-icing of cooling-fan installation at air temperature of 13° F, liquid-water content of 0.4 gram per cubic meter, fan speed of 895 rpm, and alcohol flow of 0.5 pound per minute.

Alcohol de-icing. - The results of the use of alcohol sprays are shown in figures 16 to 20. At an alcohol flow of 0.5 pound per minute and with the initial spray configurations, fairly good de-icing of the fan blades was obtained at an air temperature of 13° F and liquid-water content of 0.4 gram per cubic meter (fig. 16). A fairly heavy accumulation of slush was retained, however, on several stator vanes that were concave upward. At a higher air temperature and water content and with the same alcohol flow (fig. 17), the fan blades were only partly de-iced and all the stator vanes were partly blocked by similar deposits of slush. When the alcohol flow was increased to 1.2 pounds per minute at

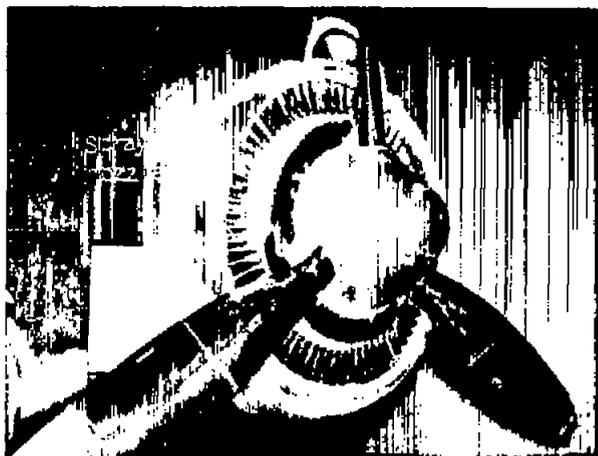
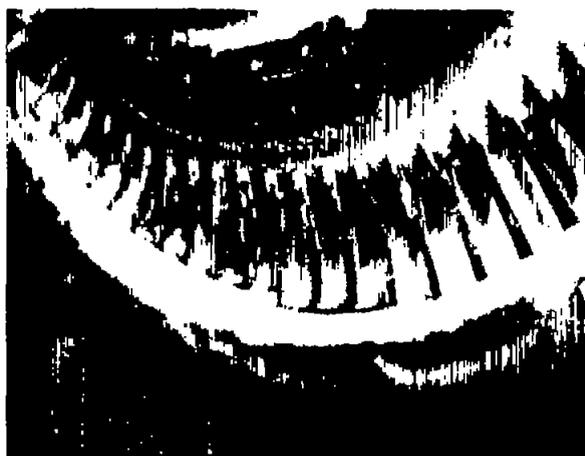
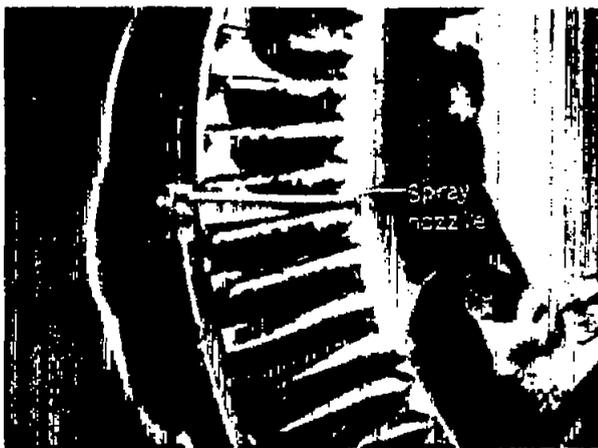
(a) General view of installation.

(b) View showing ice formations on leading edge of stator vanes.

(c) Close-up of fan blades.

Figure 17. - views showing effect of alcohol de-icing of cooling-fan installation at air temperature of 25° F, liquid water content of 1.0 gram per cubic meter, fan speed of 875 rpm, and alcohol flow of 0.5 pound per minute.

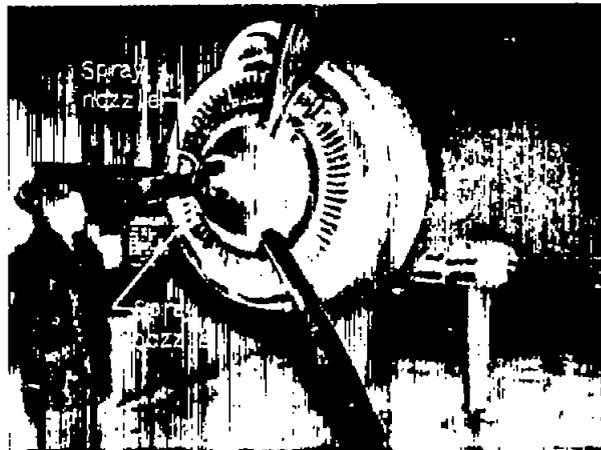
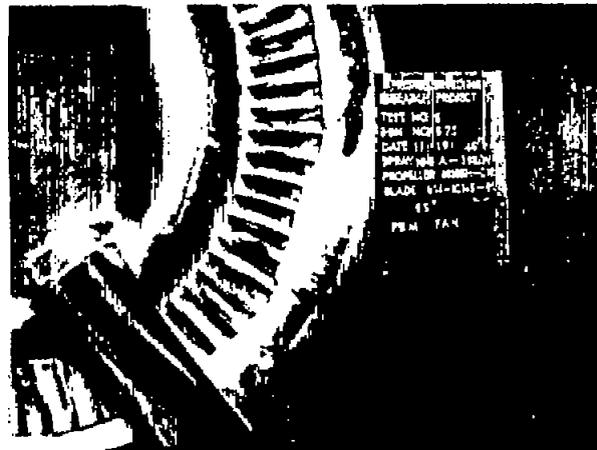
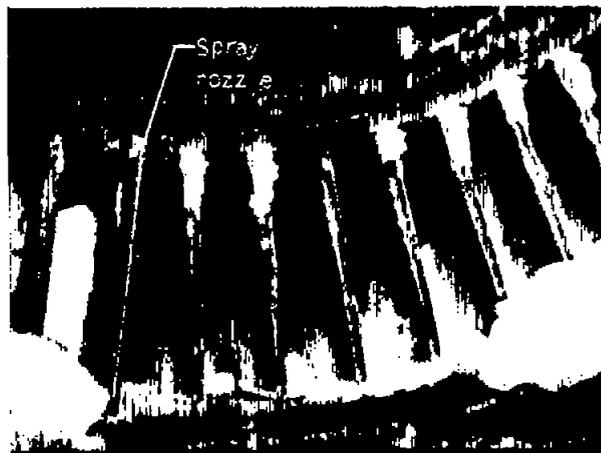
(a) General view of installation.

(b) View showing de-icing of fan blades.

(c) Close-up showing de-icing of fan blades.

(d) View looking forward through stator vanes.

Figure 18. - Views showing effect of alcohol de-icing of cooling-fan installation at air temperature of 24° F, liquid-water content of 1.0 gram per cubic meter, fan speed of 950 rpm, and alcohol flow of 1.2 pounds per minute.

approximately the same icing and speed conditions and with the second spray configuration, no improvement in de-icing was apparent (fig. 18). Although the convex face of the fan blades was almost completely clear of ice, heavy deposits of slush were as much as three-fourths inch thick at the concave-face trailing edge. The stator vanes again had large formations of wet ice and were approximately 50-percent blocked. At a medium icing condition (air temperature, 14° F and liquid-water content, 0.5 gram/cu m) and an alcohol flow of 1.5 pounds per minute, the fan blades were almost fully de-iced. (See fig. 19.) Medium formations of wet ice were found on the stator vanes immediately behind the spray tubes and only a thin coating of ice was found on the rest of the stator blades. When the alcohol flow was increased to 2.3 pounds per minute, the fan blades were again almost completely de-iced (fig. 20). Large deposits accumulated, however, on all the stator vanes. As shown by the photographs of all the alcohol de-icing (figs. 16 to 20), the alcohol-diluted ice thrown off the fan blades impinged on the stator vanes where it remained and refroze. For all conditions, configurations, and flows investigated, the use of alcohol as a de-icing agent proved ineffective because of the marginal de-icing of the fan blades and the large ice deposits obtained on the stator vanes. It is estimated that no practical amount of alcohol would satisfactorily preserve fan performance under all icing conditions.
